SERVICE BULLETIN ASM-007

Product: Antenna System Monitor

Subject: Firmware 2.10 Release

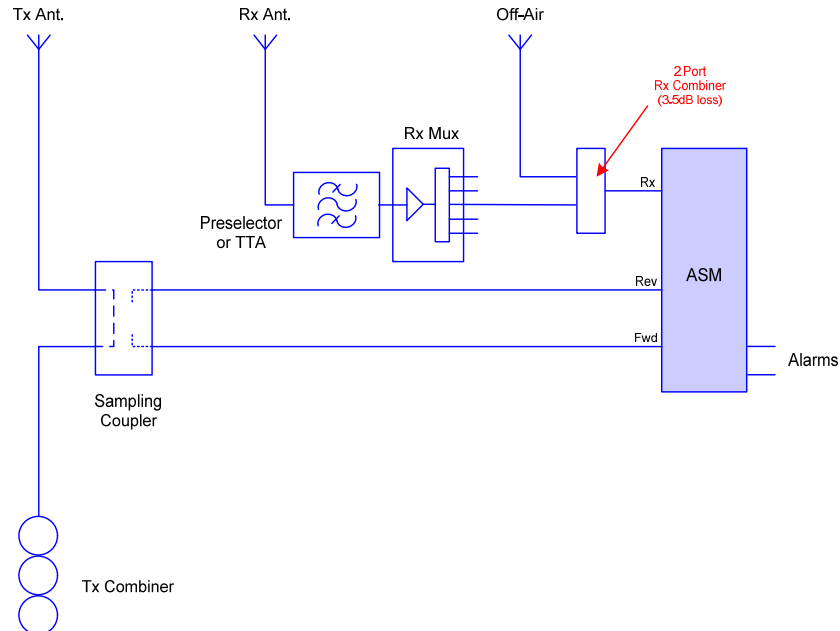
This feature allows the inclusion of a value for an addition loss that may be introduced into the Rx path by a multi-input combiner when 2 or more Rx paths are being used in the ASM installation. This value is then added into the calculation of Rx Level and Antenna Isolation values.

Example Installation – Rx Post Gain (Loss) component shown

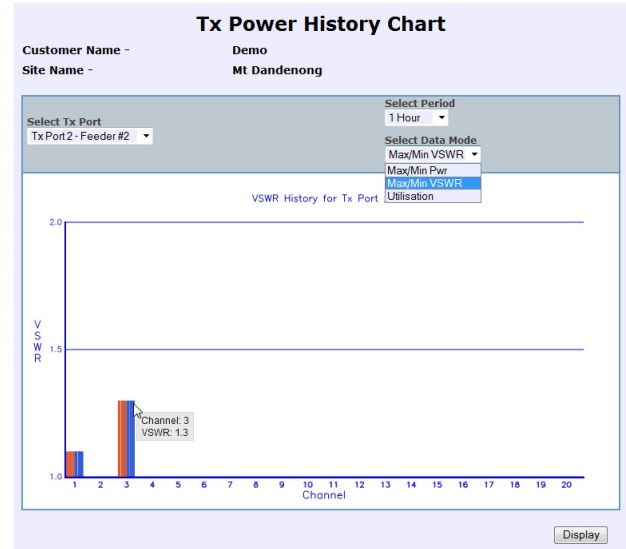
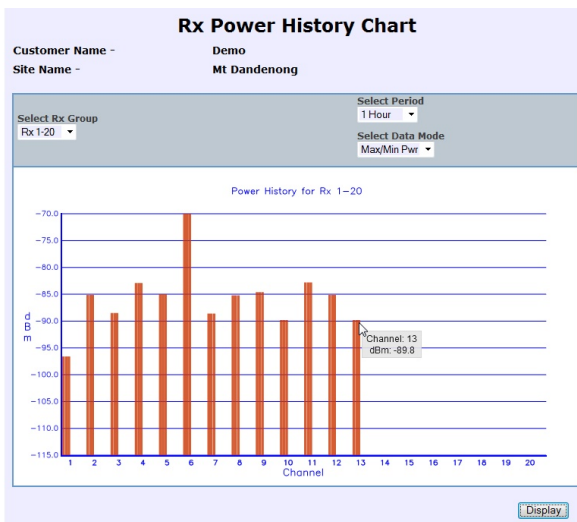
Additional History Graph selections are now available. Tx VSWR and Rx Level and Rx Utilisation displays may now be selected under the *History* menu.

Hovering the mouse near the top of a line will show the displayed value.

In these displays, only values that exceeded the entered threshold values are displayed.
