SERVICE BULLETIN ASM-022

Product: Antenna Systems Monitor

Subject: Firmware 2.83 Release

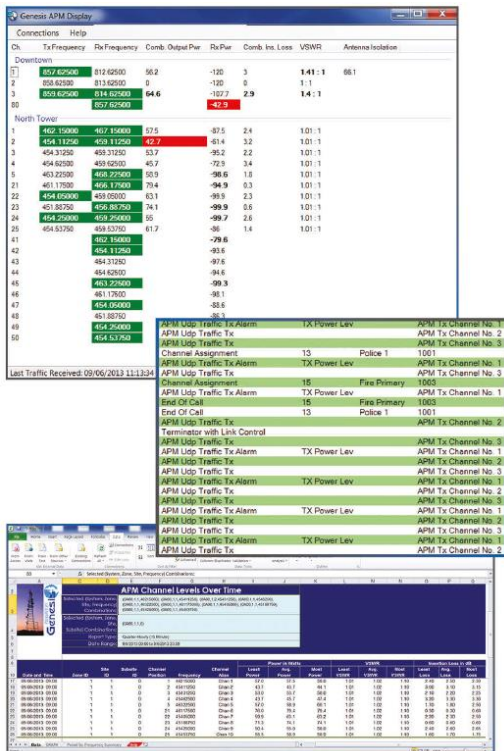
Genesis GenWatch™ screen examples

The ASM is already supported by Genesis GenWatch™, and also by C² Systems SitePortal® monitoring software packages. Many SNMP Manager software packages also support the ASM's SNMP alarm capabilities.
